# **Pentium® Pro Processor Specification Update**

Release Date: September 1998

Order Number: 242689-031

The Pentium® Pro processor may contain design defects or errors known as errata which may cause the product to deviate from published specifications. Current characterized errata are documented in this Specification Update.

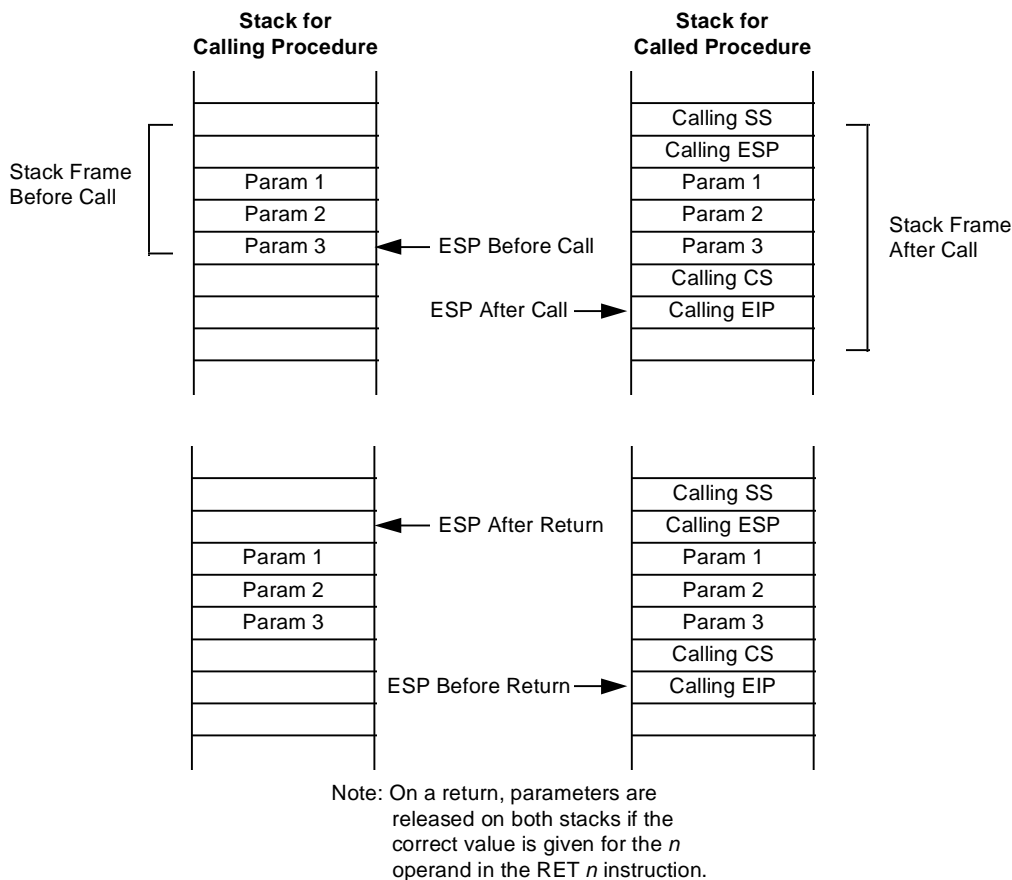
**Figure 4-3. Stack Switch on a Call to a Different Privilege Level**

When making a call to a more privileged protection level, the processor does the following (see Figure 4-3):

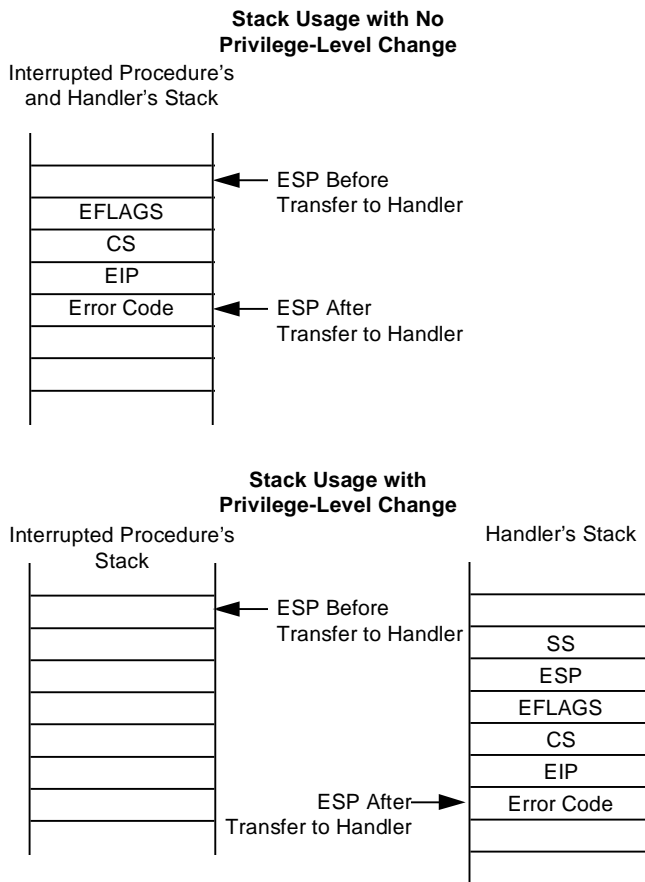
**Figure 4-4. Stack Usage on Transfers to Interrupt and Exception Handling Routines**

1. Performs a privilege check.
2. Restores the CS and EIP registers to their values prior to the interrupt or exception.
3. Restores the EFLAGS register.

4. Restores the SS and ESP registers to their values prior to the interrupt or exception, resulting in a stack switch back to the stack of the interrupted procedure.
5. Resumes execution of the interrupted procedure.
